Property: **GILFORD YACHT CLUB CONDOMINIUM ASSOCIATION**
1996 Lake Road, Gilford, NH 03249

Service: 22-019-NH - FULL RESERVE STUDY

FULL RESERVE STUDY
GILFORD YACHT CLUB CONDOMINIUM ASSOCIATION
1996 LAKE ROAD
GILFORD, NH

Site Inspection Date: June 6, 2022
Final Report Submitted Date: March 8, 2023

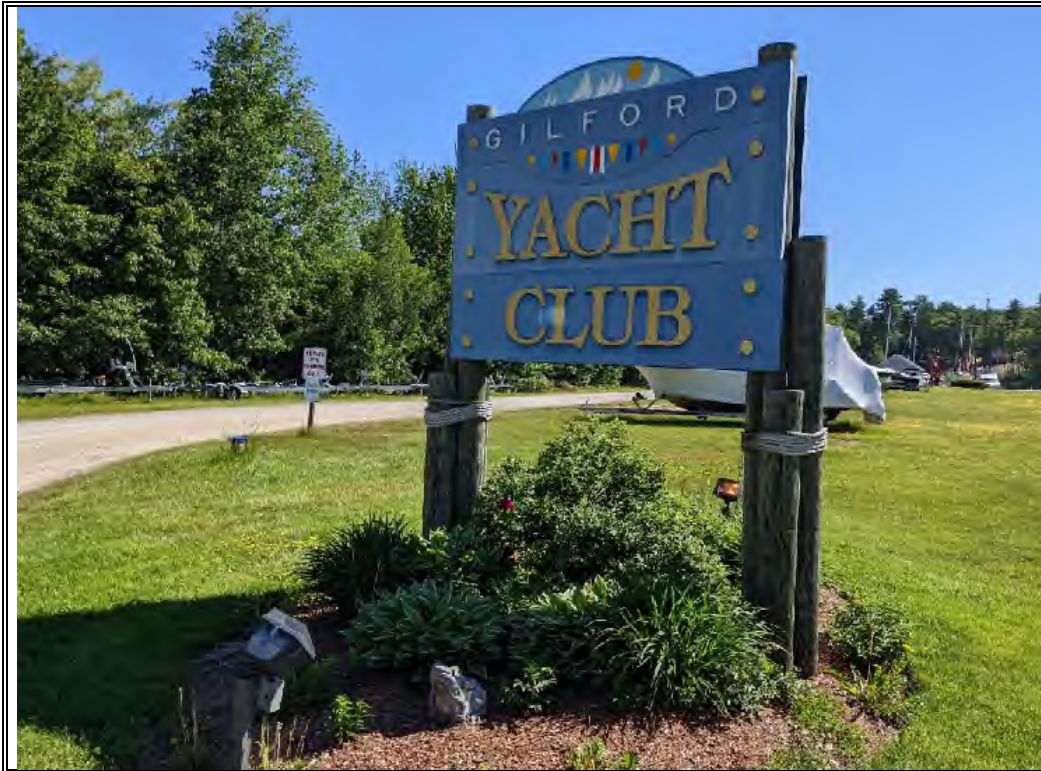
Photo Number
1

Description:
entrance sign

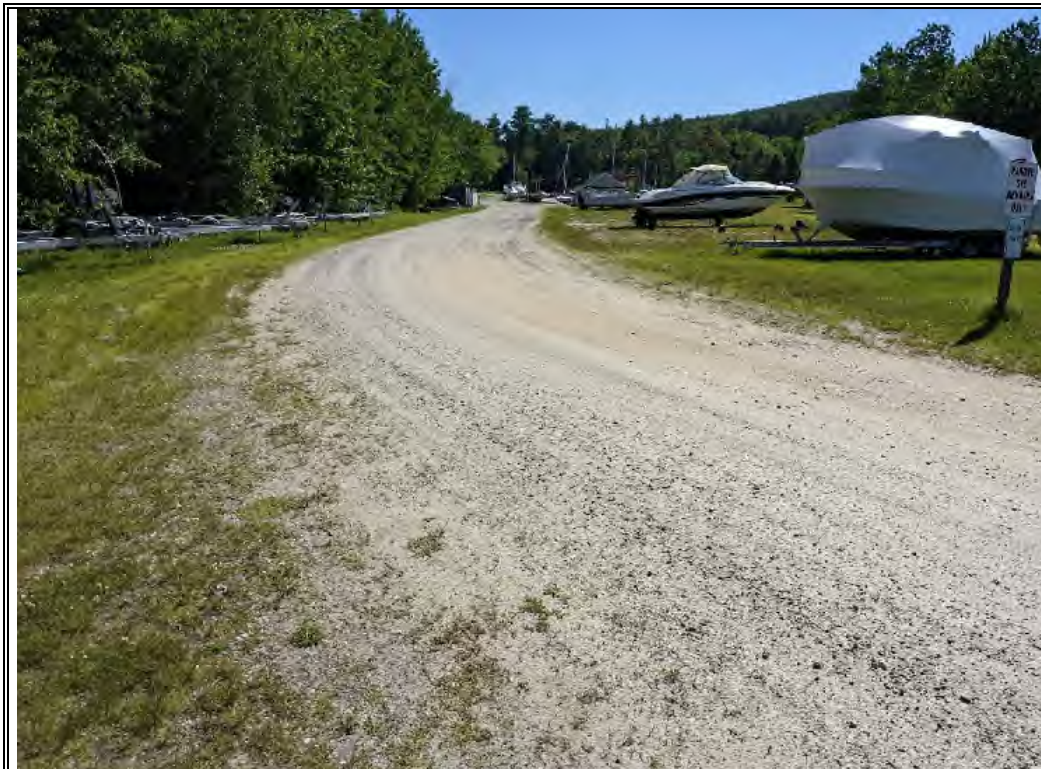
Photo Number
2

The gravel driveway was in good condition at the time of our visit. This is expected to require annual maintenance and periodic repair of potholes. We do not include this maintenance and repair work as part of a reserve fund study.

Description:
gravel drive

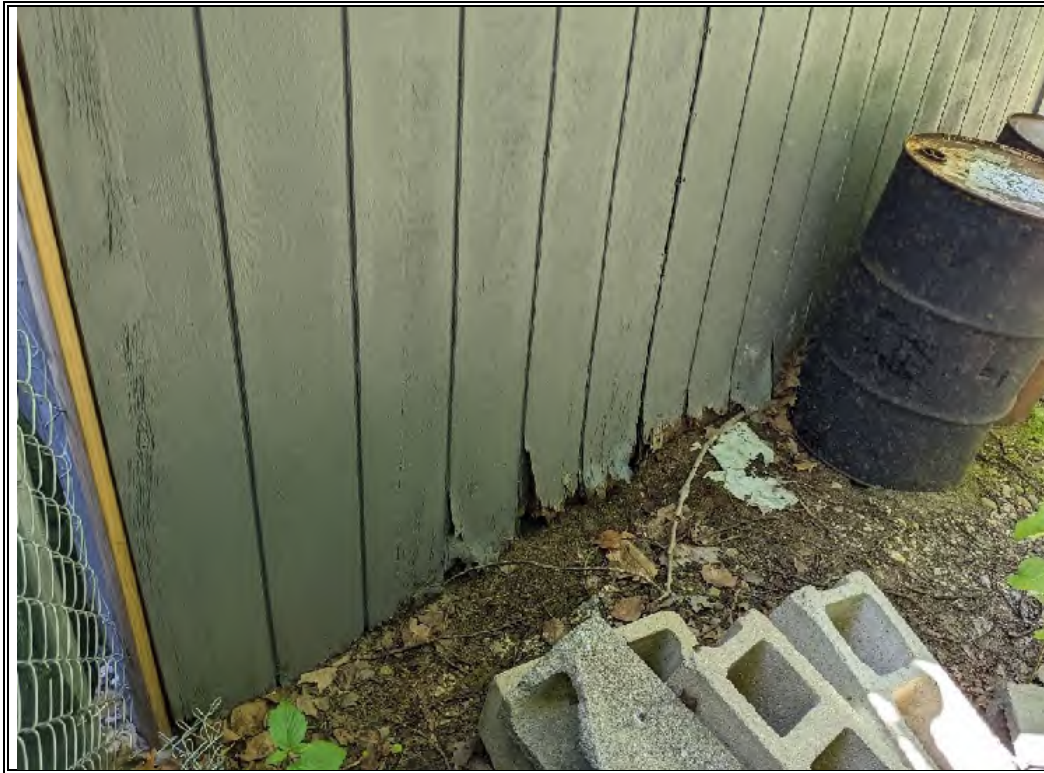
Photo Number
5

The storage building is in fair condition. The asphalt shingles covering its shed roof appear in good condition, but the siding is in need of repairs. We budget to alternate between re-shingling the roof and

Description:
shed
deterioration of
siding at rear

making repairs to siding on a 10 year basis, starting in 2023. Unused funds may also be used to make periodic repairs to the building and replace hardware.

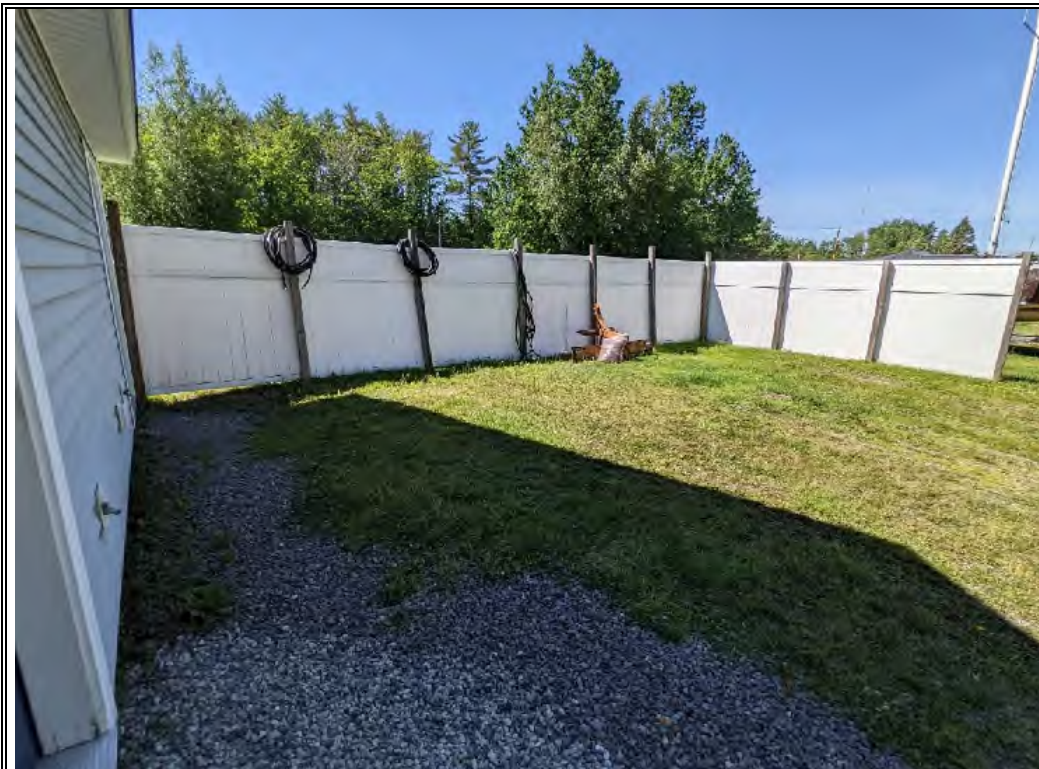
Photo Number
8

The vinyl privacy fence to the west of the building is in fair condition. Its posts are not well secured and the subsequent movement created by wind has loosened fasteners and other connections. We budget for replacement of this fence in 5 years.

Description:
clubhouse
fence

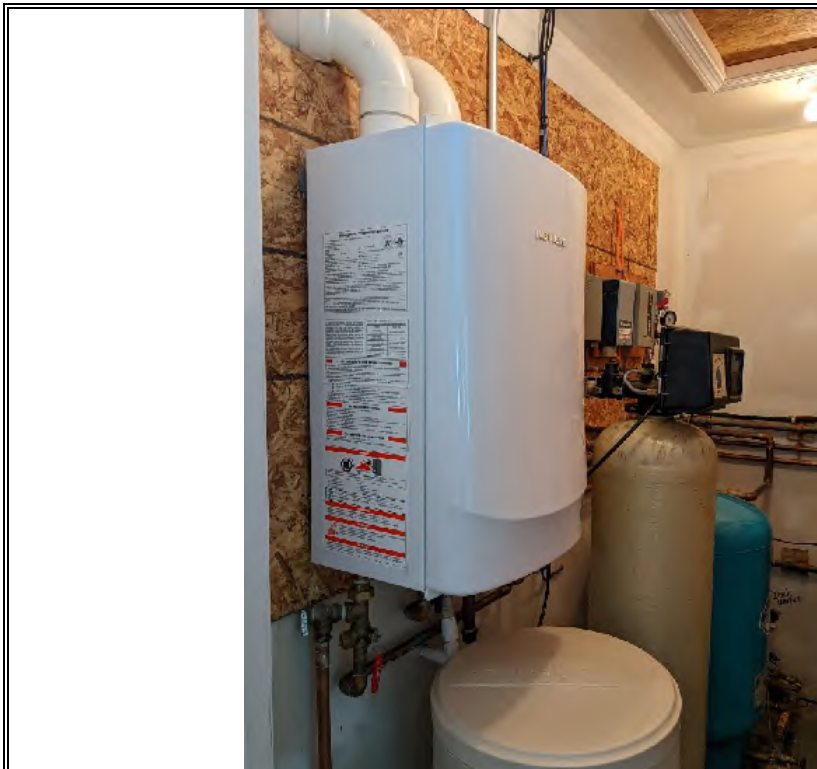
Photo Number
12

A Navien brand, on-demand, LP fired, domestic water heater is located in the utility room. This unit looks in good condition and we provide a budget for its replacement in 20 years.

Description:
clubhouse
water heater

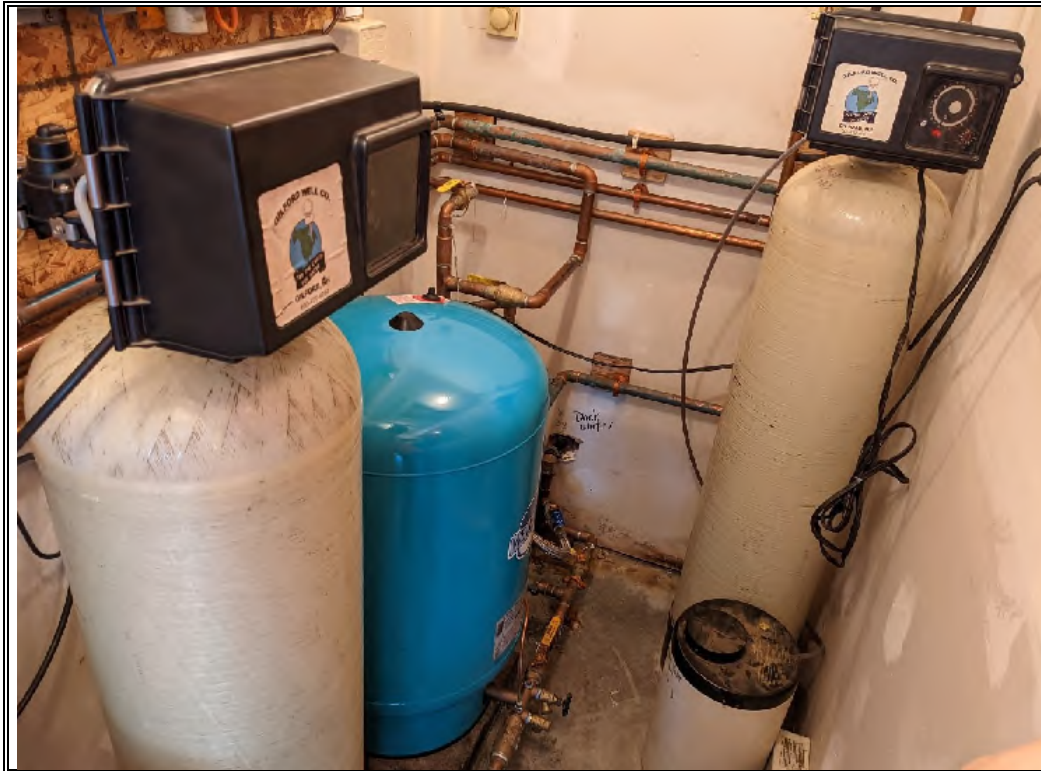
Photo Number
13

A driven well with pump is located at the right side of the entrance. No information on the capacity of this system was provided. The pressure tank, pump controller, and filtration equipment for this system are located in the clubhouse utility room. We provide a budget to replace the pressure tank, various fittings and well pump and its controller on a 20 year cycle.

Description:
clubhouse
well pump
controller, pressure
tank and filtration
system

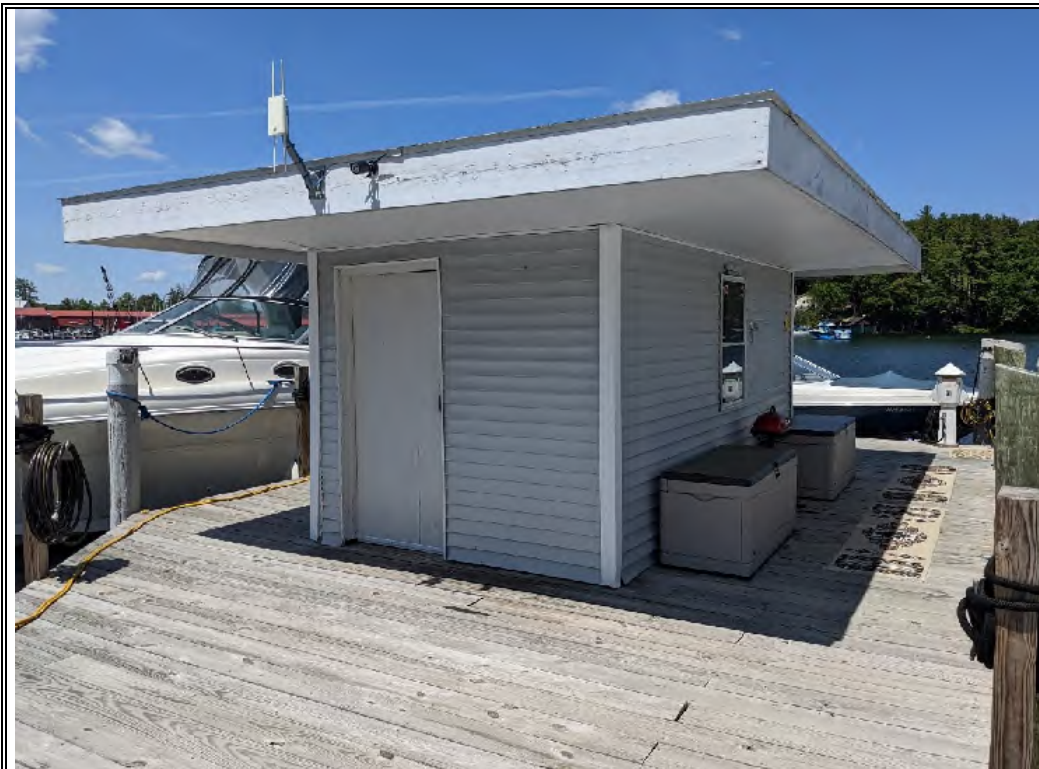
Photo Number
20

The rubber membrane roof of the dockhouse is in good to fair condition. We budget for its replacement in 2039. With the added reflective UV exposure, we also anticipate replacement of vinyl siding on this building after 20 years of service. We budget for this work in 2033.

Description:
dockhouse

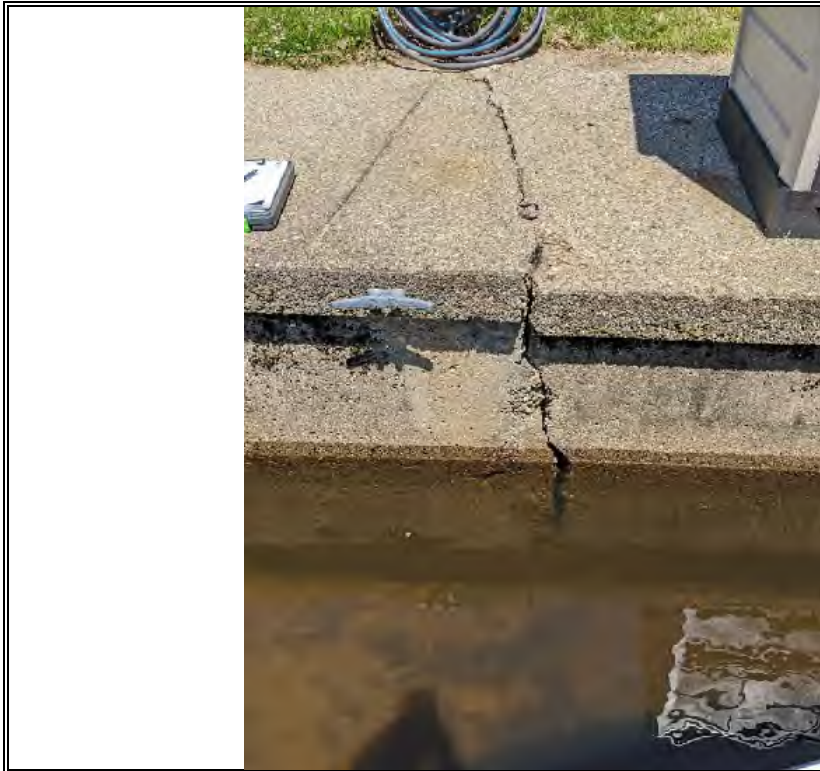
Photo Number
21

Condition 1 - A vertical, triangular shaped crack (larger at the top than bottom) with weathered edges was observed through the stemwall and footing of the seawall at slip 22. This suggests differential settlement has been occurring in this area for some time. We do not expect this condition to be a significant concern over the next 10-12 years, but would anticipate maintenance at the surface to correct minor settlement or expanded cracking at the walkway.

Description:
seawall
Condition 1

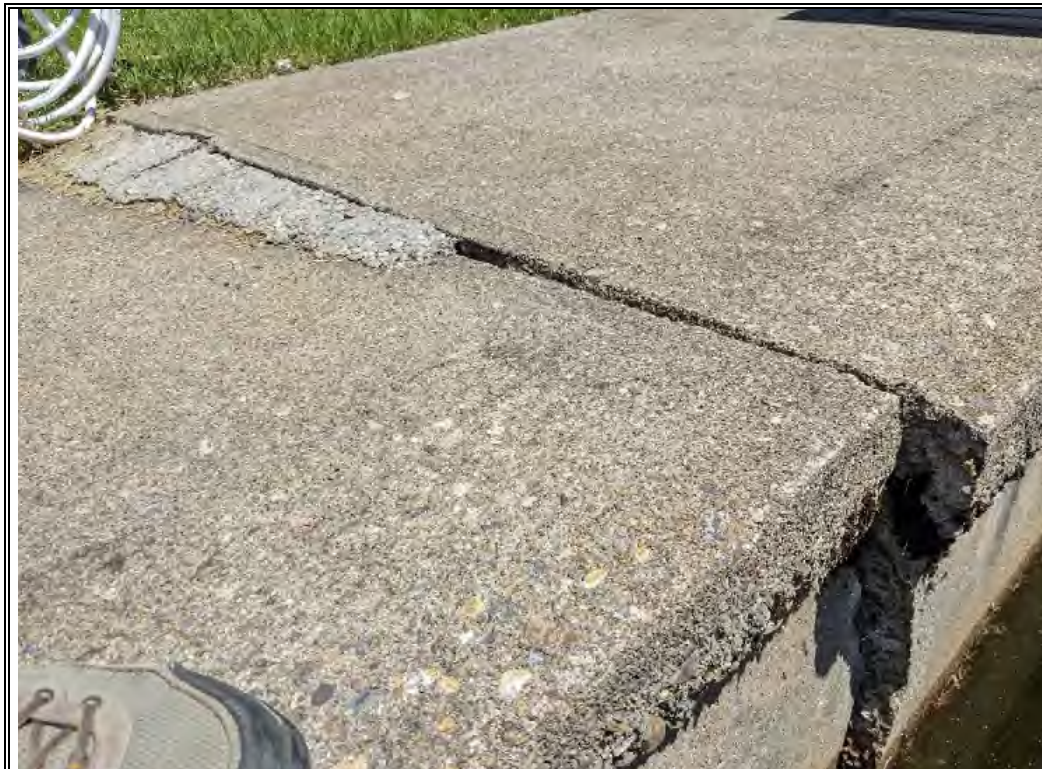
Photo Number
22

Condition 2 - A vertical crack found at slip 34 presents a more concerning condition where overturning (tipping) of the wall is occurring for a distance of approximately 25 feet to where the concrete walkway ends. The concern is that the movement appears to still be active. To the east side of slip 35, new wood decking was reportedly installed 5-6 years ago and is in contact with the out-of-plumb portion of the seawall. Planking boards of this deck which are in contact with the seawall have lifted and become trip hazards, likely as a result of an active overturning condition.

Description:
seawall
Condition 2

Over the short term, we budget for efforts to stabilize 45 feet of seawall at slip 01 (Condition 3 above), and 25 feet of seawall behind slips 34 and 35 (Condition 2 above).

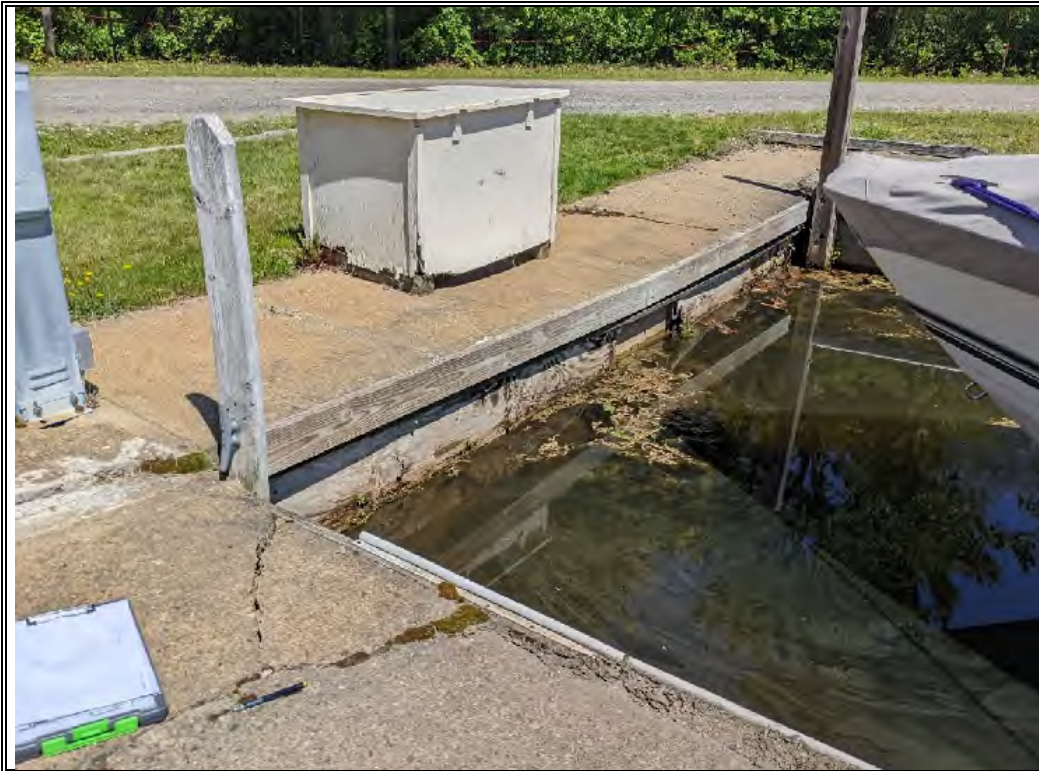
Photo Number
23

Condition 3 - The seawall and concrete slabs at the end of slip 01 are in poor condition. Plywood appears to have been installed on the water side of the stemwall in an effort to retain portions of concrete which are deteriorating and falling away. As this is the only location where a drainage pipe penetrates the wall, it is probable that retained material around the pipe has migrated through the headwall (a process referred to as "piping"), creating voids which has allowed settlement of the slab above, and the wall itself.

Description:
seawall
Condition 3

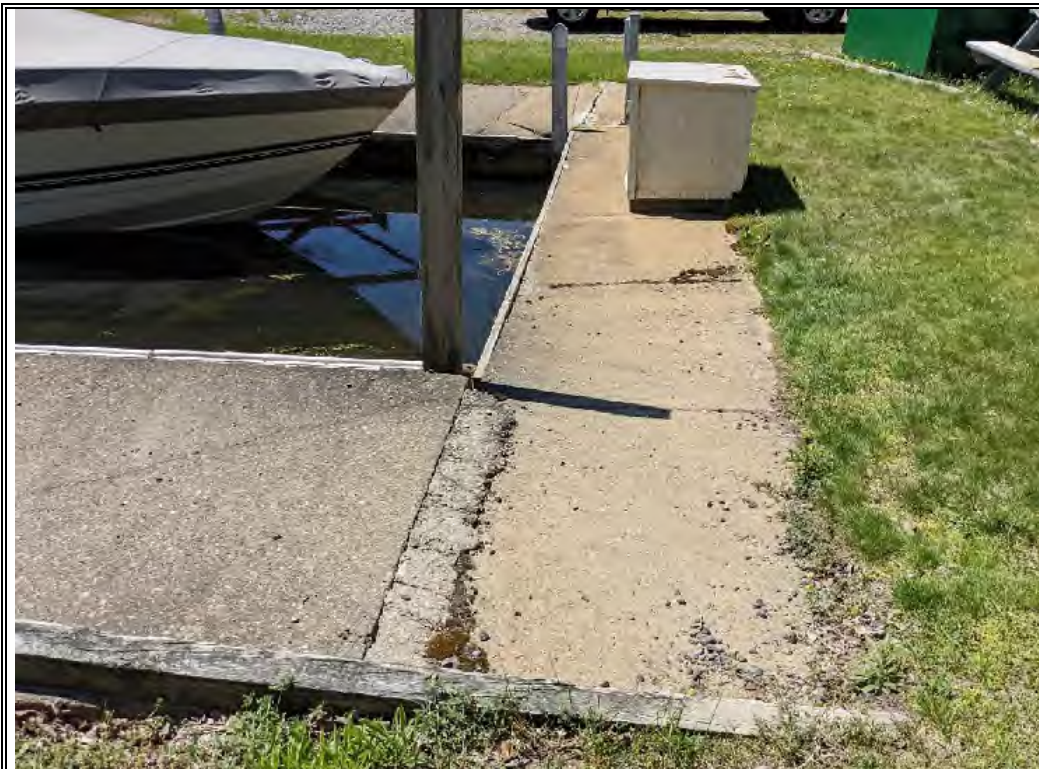
Photo Number
24

Description:
seawall
Condition 3

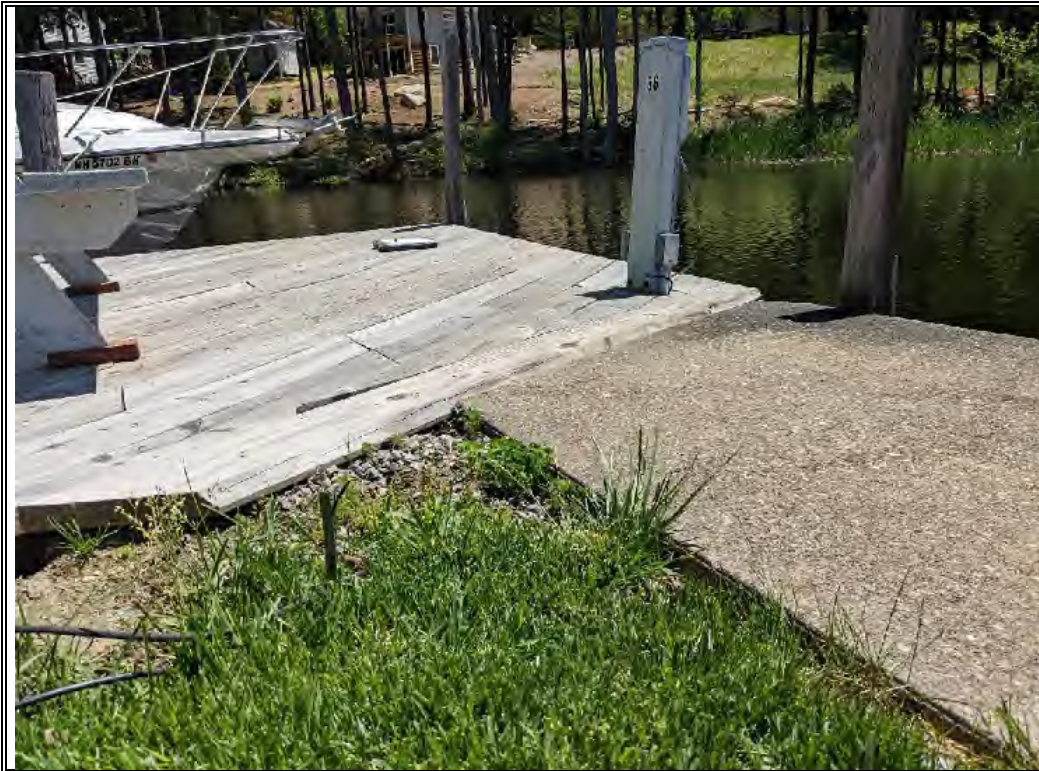
Photo Number
25

Description:
seawall
Condition 2

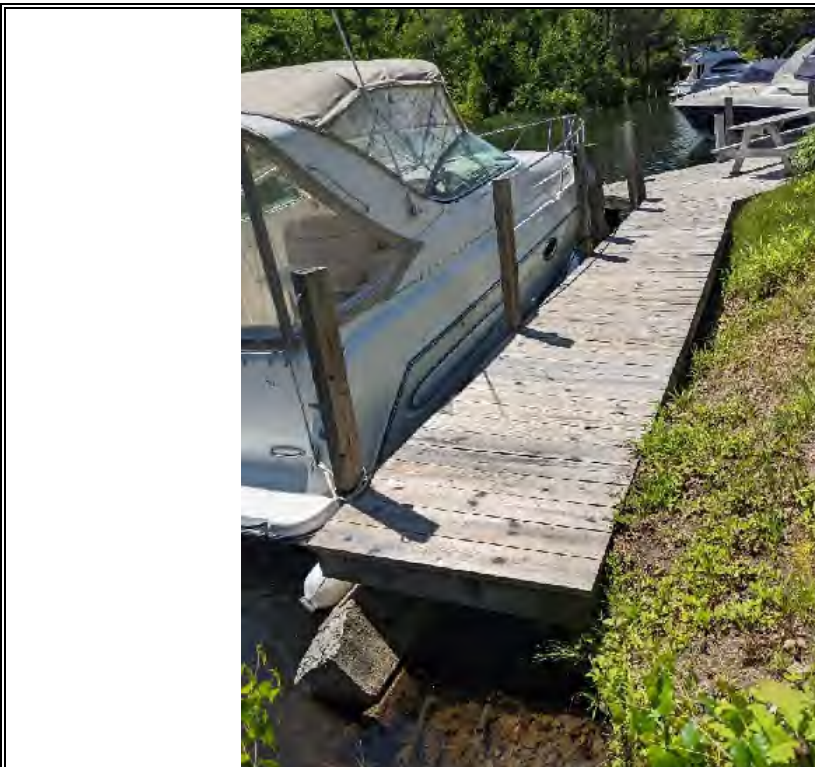
Photo Number
26

Description:
slip 36

We also recommend maintenance efforts over the next 10-12 years to enhance shoreline protections at slip 36, slip 50 and along the west side of the building. At the west side of the building, a wood plank retaining wall is used to retain the shoreline, and is overturning. Slip 36 has dock supports founded on a concrete shore protection element that appears to be sliding away from shore and pushing/damaging the embedded wood piles. Slip 50 utilizes concrete docks similar to those used at slips 4-35 and are not securely founded and unlevel. Permanent improvements are expected to be delayed until such time as these areas can be included as part of the replacement seawall program described above. We therefore include their budget as part of that work.

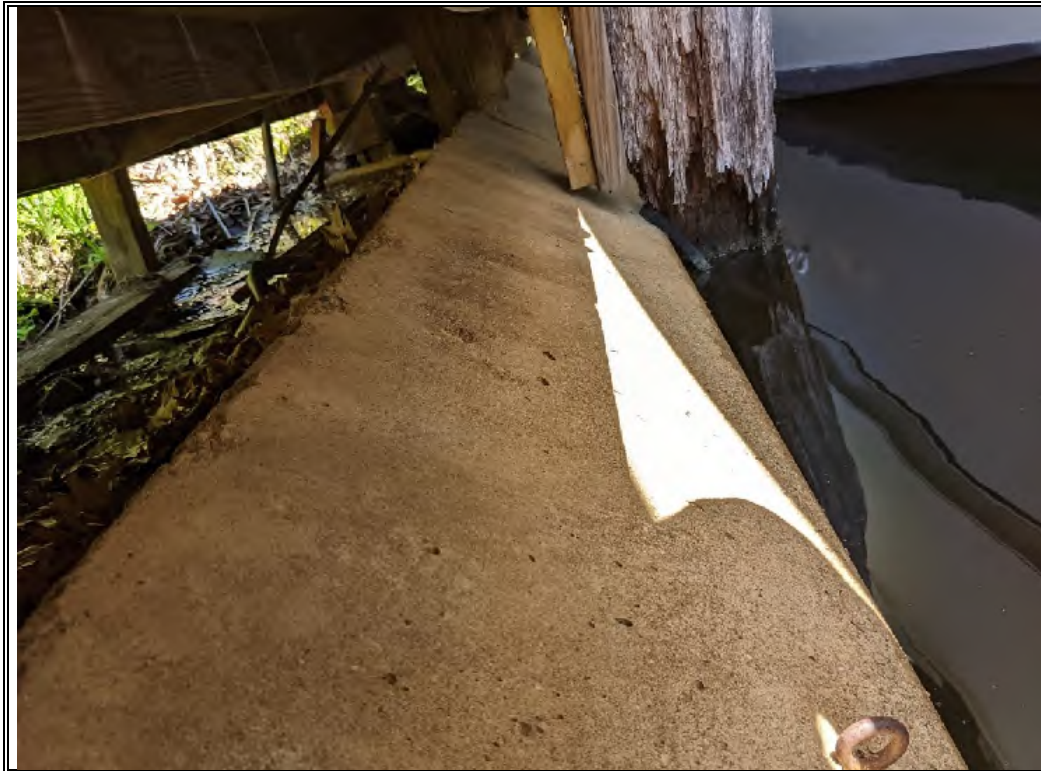
Photo Number
27

Description:
slip 36

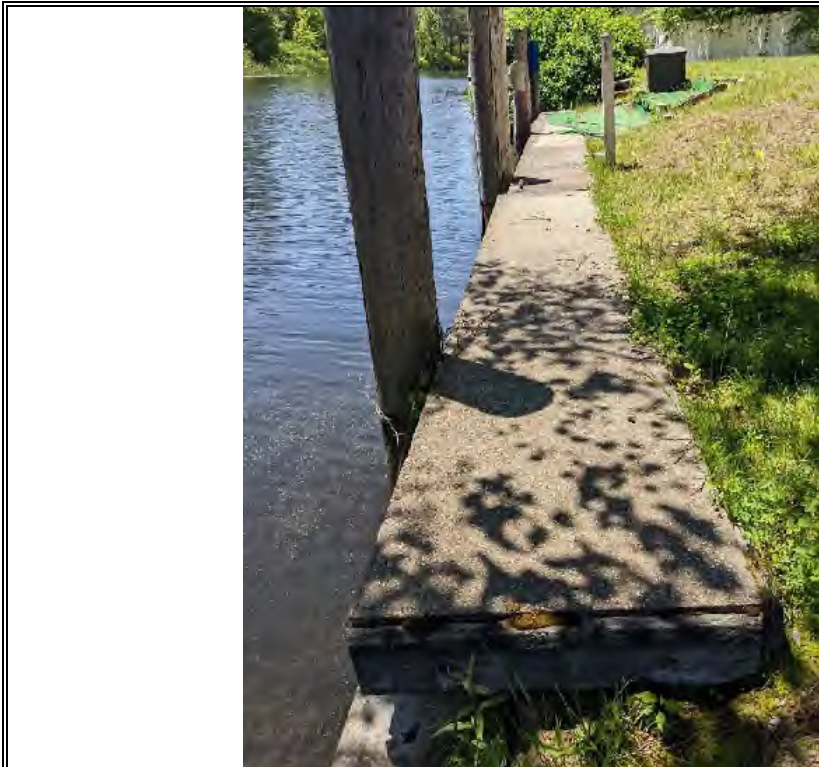
Photo Number
28

Description:
slip 50

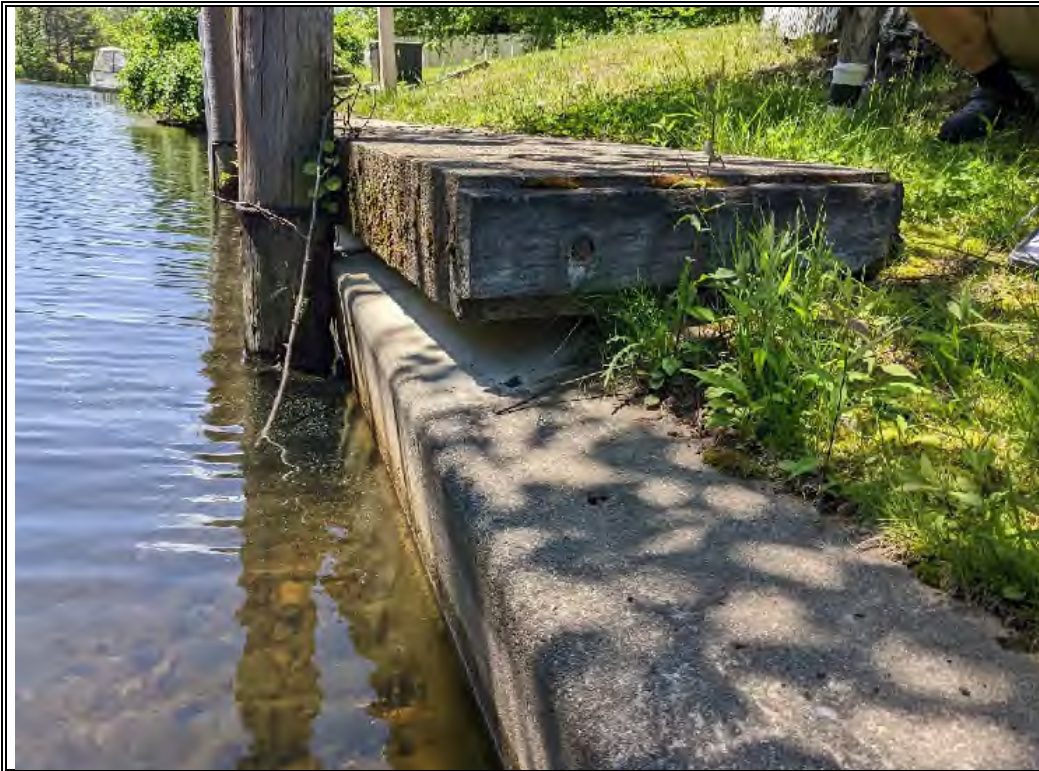
Photo Number
29

Description:
slip 50

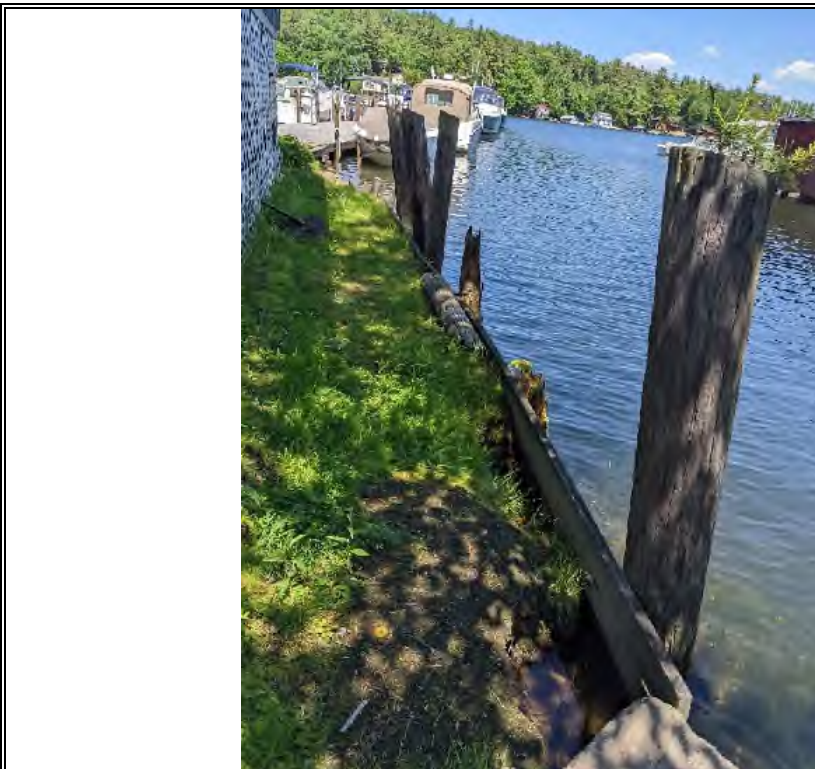
Photo Number
30

Description:
wood seawall next
to bathhouse

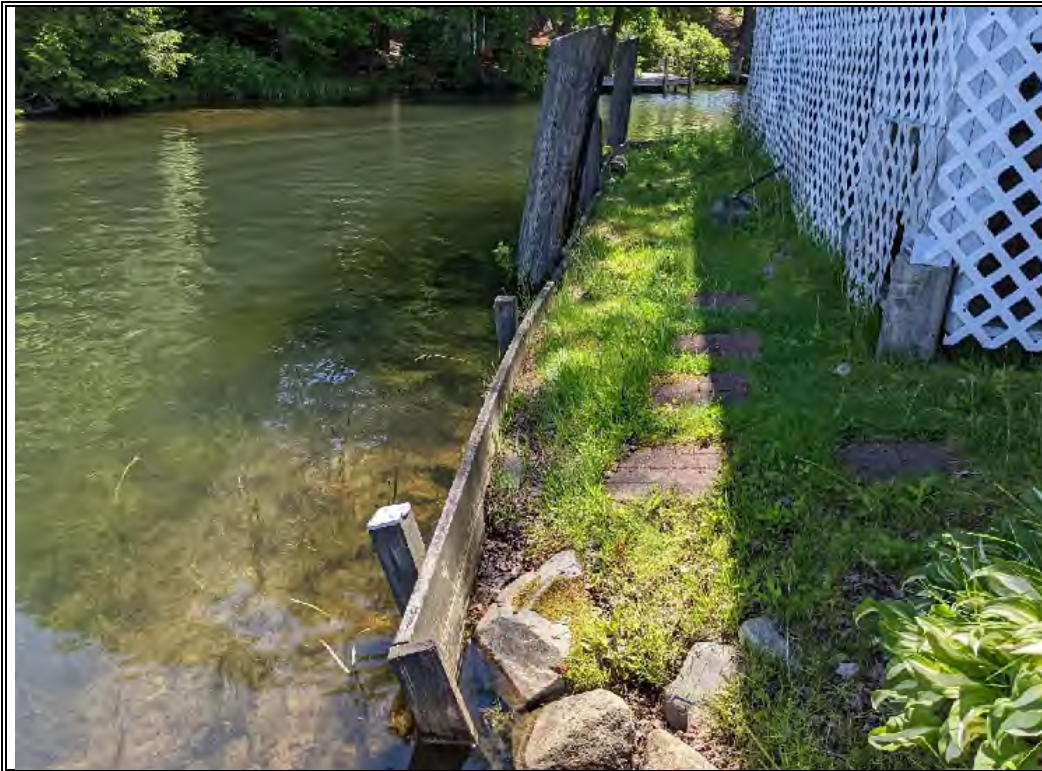
Photo Number
31

Description:
wood seawall next
to bathhouse

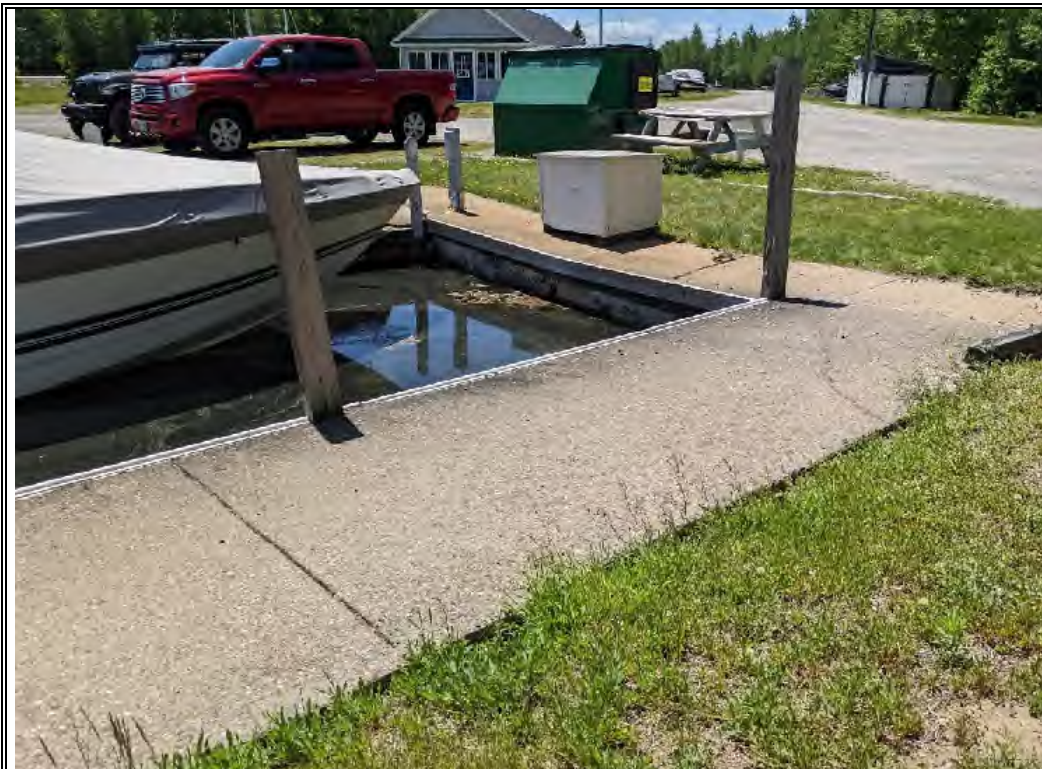
Photo Number
32

Description:
seawall
Condition 3

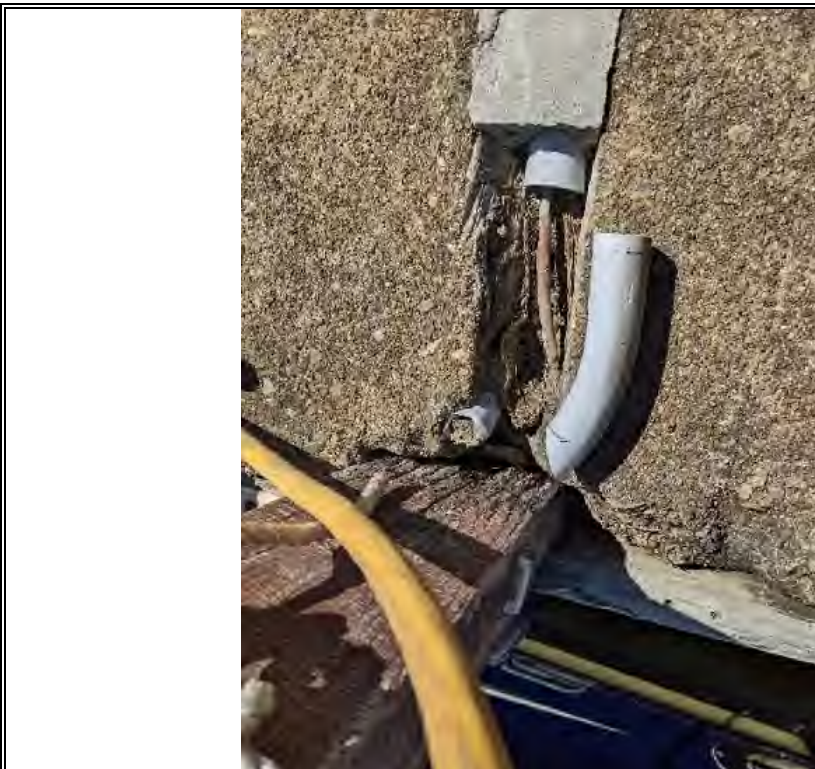
Photo Number
36

Description:
apparent
abandoned wiring
found at
construction joints
of walkway
between slips 54 &
60

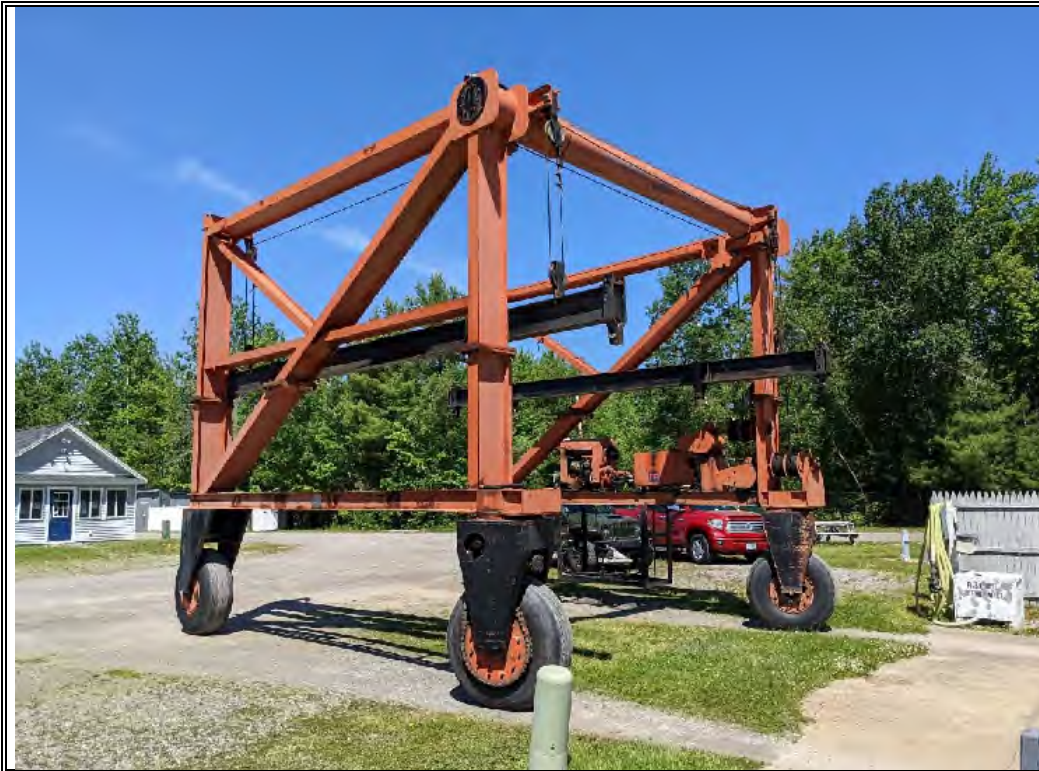
Photo Number
37

The boat crane allows members to annually take their boats out in the fall and put them in the water in the spring. This unit appears older and if not already, replacement parts will become more difficult to obtain. As this service is a vital function of the club, we suggest that the Association budget to replace this crane in 15 years.

Description:
25 ton boat crane
